Re: 924 York Avenue  
Manitowoc, WI

# Asbestos Pre-Demolition Inspection Report

Commercial Property  
924 York Ave  
Manitowoc, WI 54220

SUBJECT: Asbestos Pre-Demolition Inspection  
924 York Ave. Manitowoc WI 54220

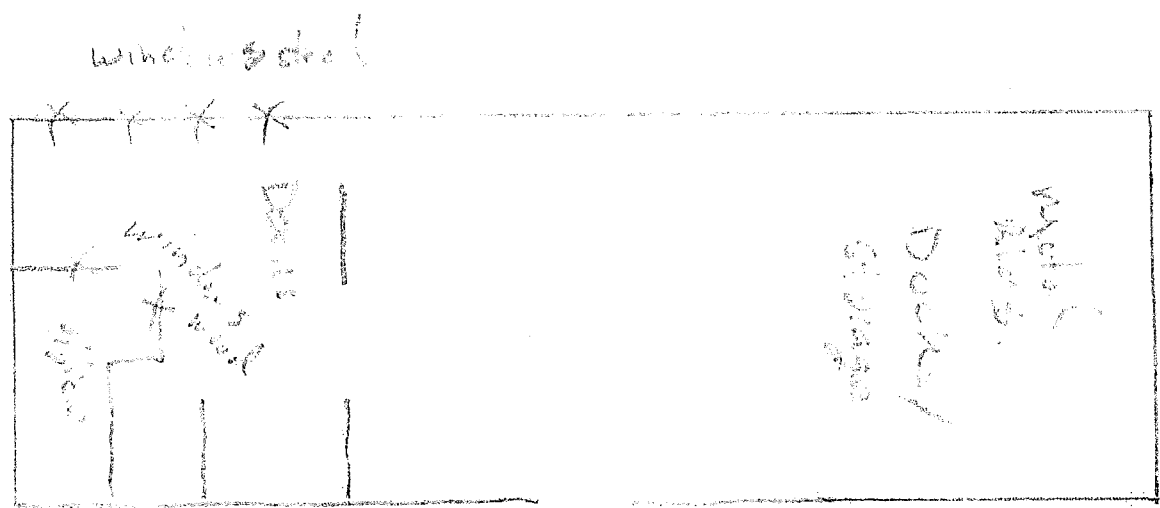
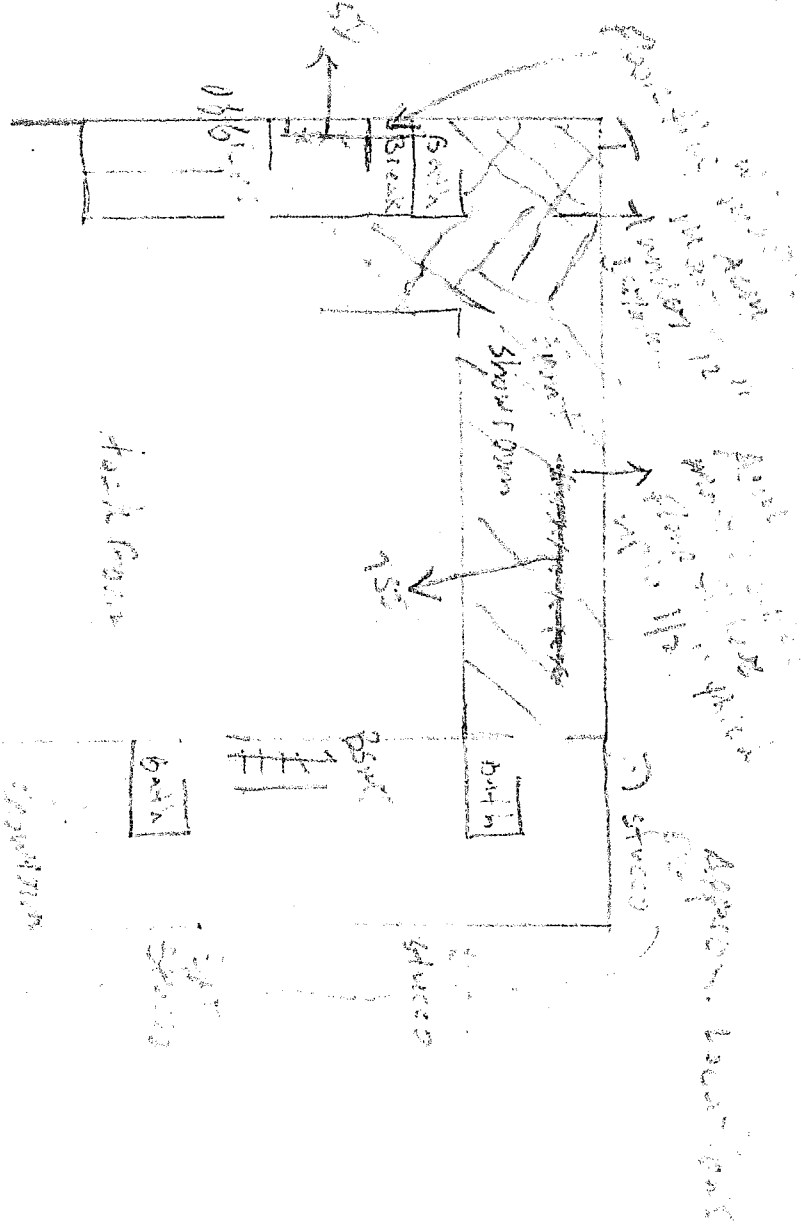
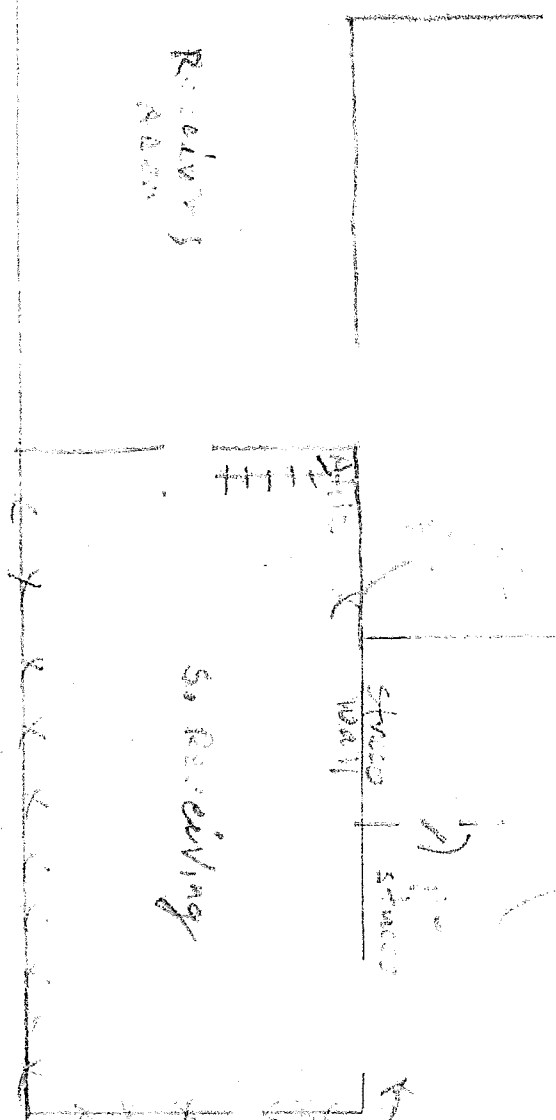
The window units which tested positive for ACM glaze are listed below:

N/W Storage Office/Loading	2 each 4' W x 2' T wood single framed
	4 each 4' W x 5' T steel single framed
South Receiving Area	10 each 3' W x 2' T wood single framed
	7 each 2" W x 3' T wood single framed (boarded up)

Not all facility window units glazing compound tested positive for the presence of asbestos. A representative sampling plan of existing facility windows was conducted. Positive window units are listed in the ACM inventory section of this report and should be removed as part of the abatement process. Below is a listed all facility windows, if it is determined to error on the side of caution and have all windows removed as Category II non-friable ACM.

**N/W Storage Area- 2 each 2'x4' ACM wood single framed**  
**Old loading dock 4 each 4'x5' ACM steel framed**  
**Samples # 23, 24**

**South Receiving 10 each 2'x3' ACM wood single framed**  
**Area 7 each 3'x2 ACM wood single framed**  
**Sample # 31, 33**
