August 10, 2023

**Re: Pre-Demolition Report – Asbestos**  
Former School Building  
1416 Grand Avenue  
Manitowoc, Wisconsin 54220

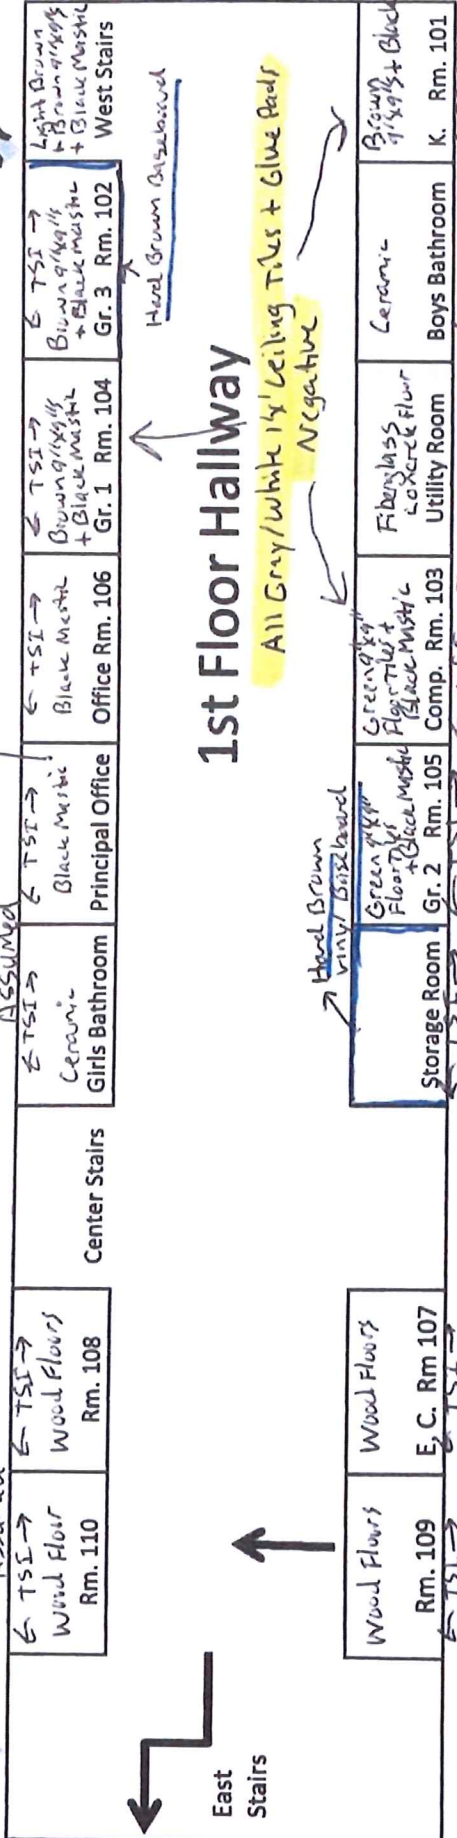
## 1st Floor Hallway

All Gray/white 1x1' Ceiling Tiles + Glue Pads  
Negative

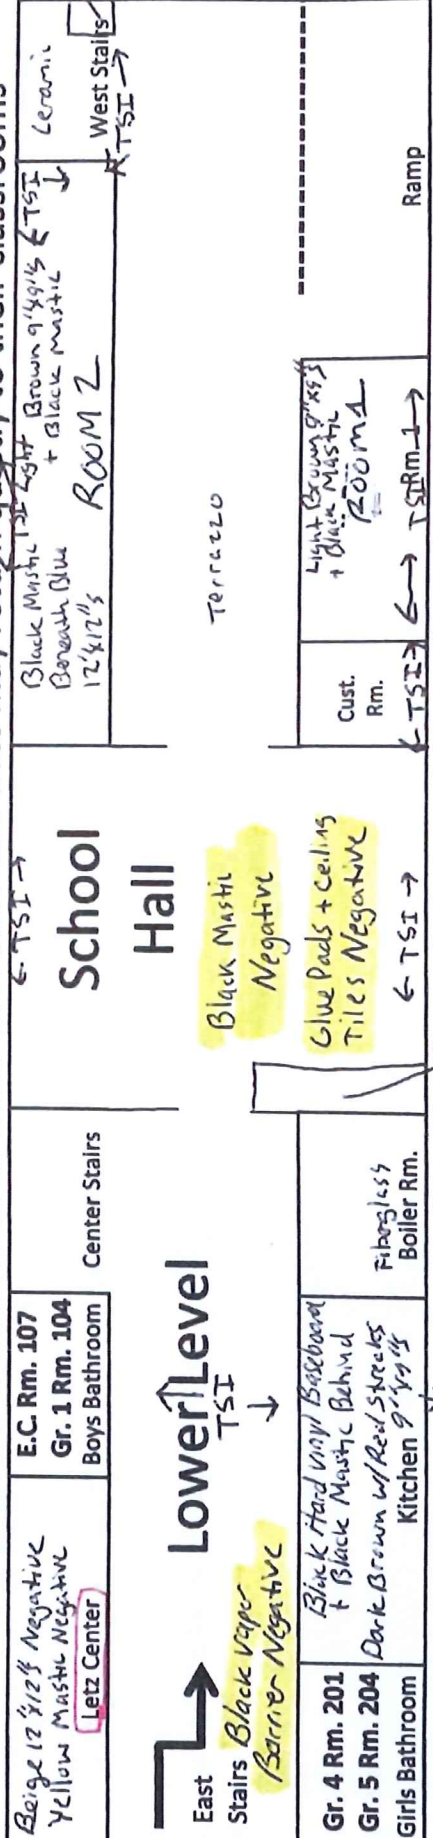
## Lower Level

Black Mastic Negative  
Blue Pads + Ceiling Tiles Negative

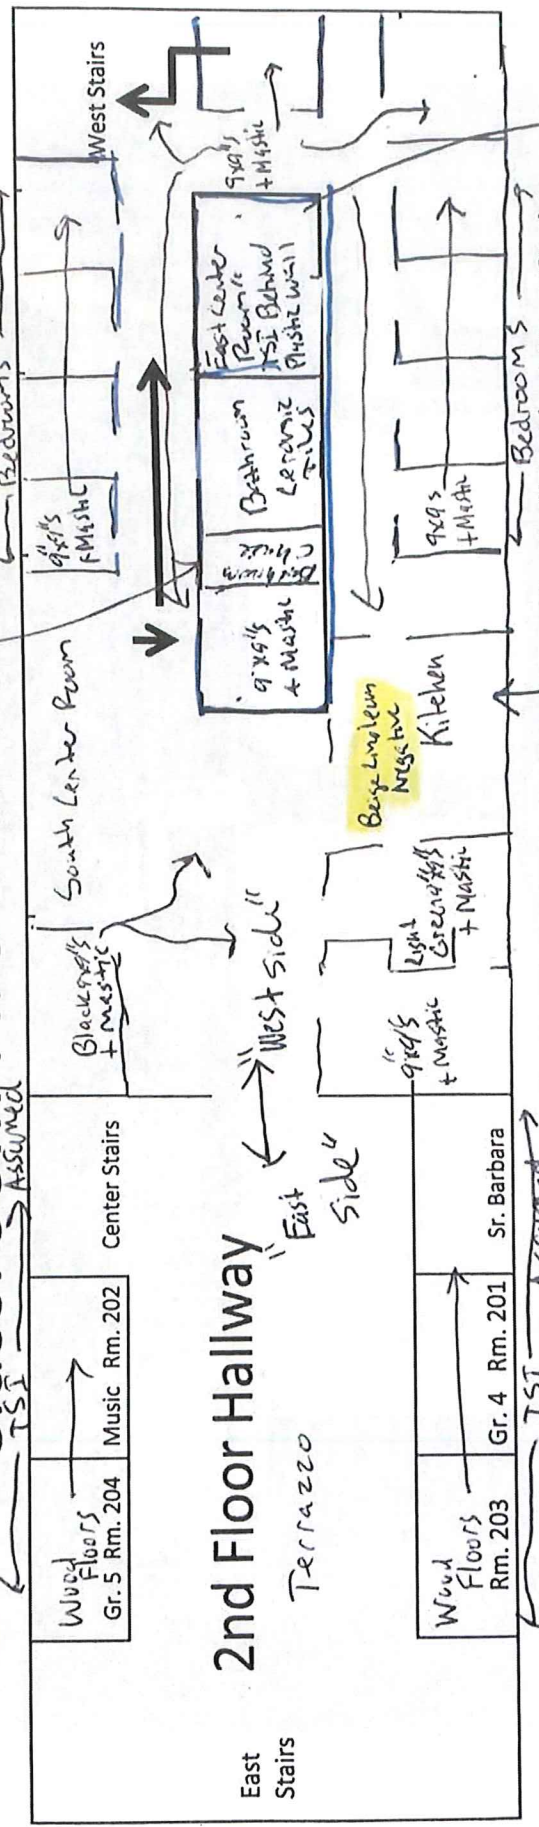
2nd Floor Hallway

9' x 9' + Mastic

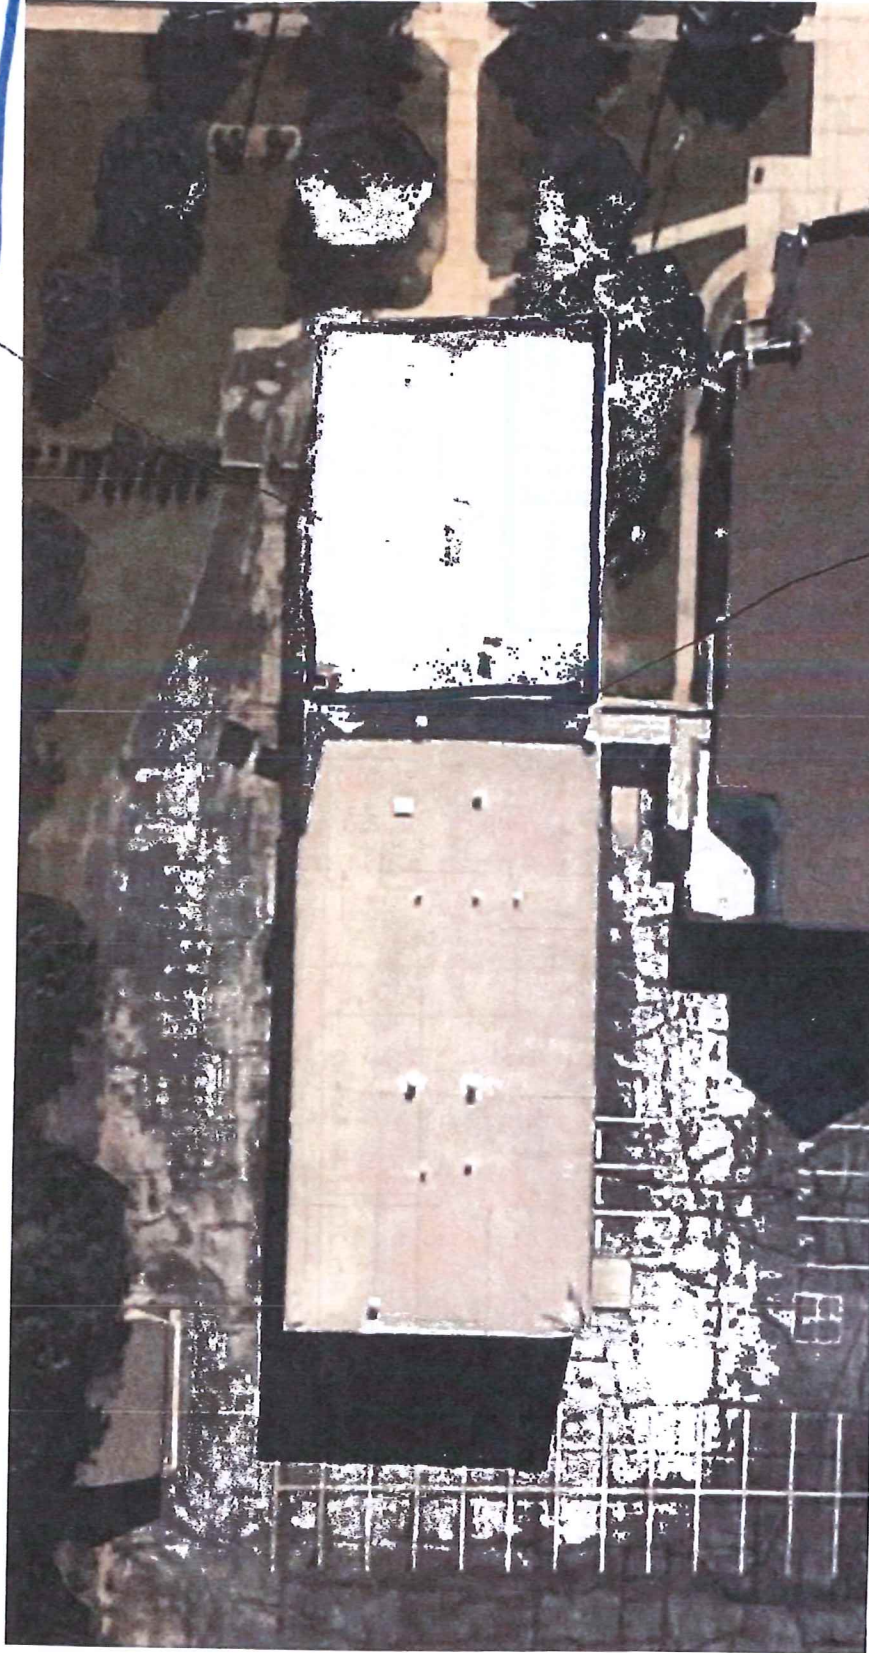
# Roof ACM Location

ACM Glue/Mastic Beneath  
Black Rubber Roofing Field

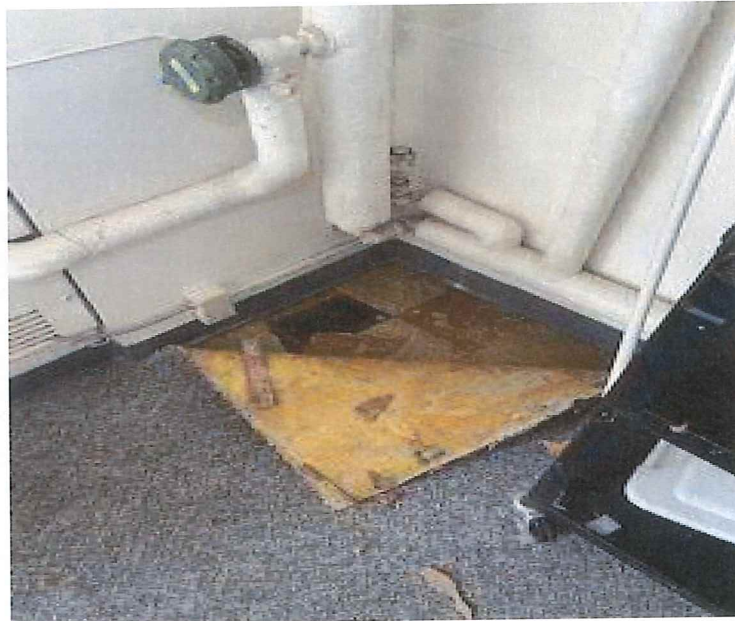
Photograph 1 – A view of the light brown and dark brown 9"x9" floor tiles and black mastic in lower-level room 2.

As the results of this survey indicated the presence of ACM in connection with the subject structure, Keystone recommends that the identified ACM be removed and disposed of by a Wisconsin-licensed asbestos abatement contractor prior to any renovation or demolition activity that will disturb the asbestos containing materials identified.

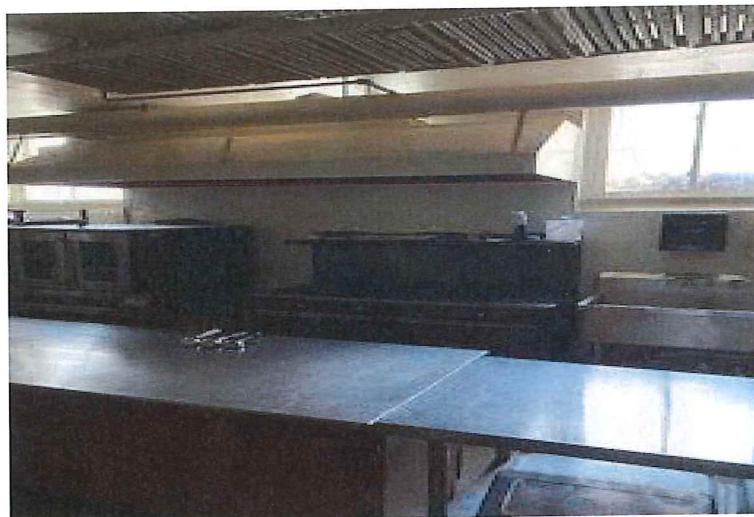
Photograph 2 – A view of the lower-level kitchen with dark brown w/ red streaks 9"x9" (negative black mastic) floor tiles and hard black baseboard and associated mastic .

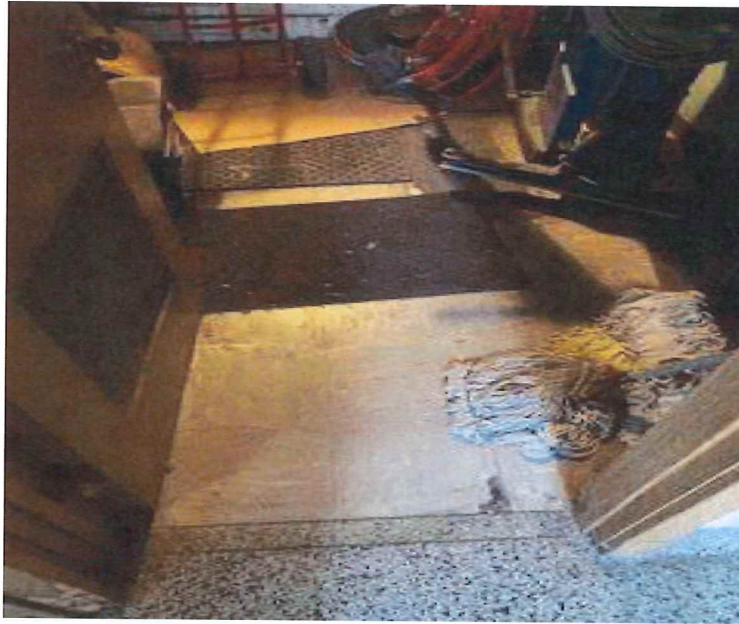
Photograph 3 – A view of the gray w/ red streaks 12"x12" floor tile and associated mastic in the lower level refrigeration/mechanical room.

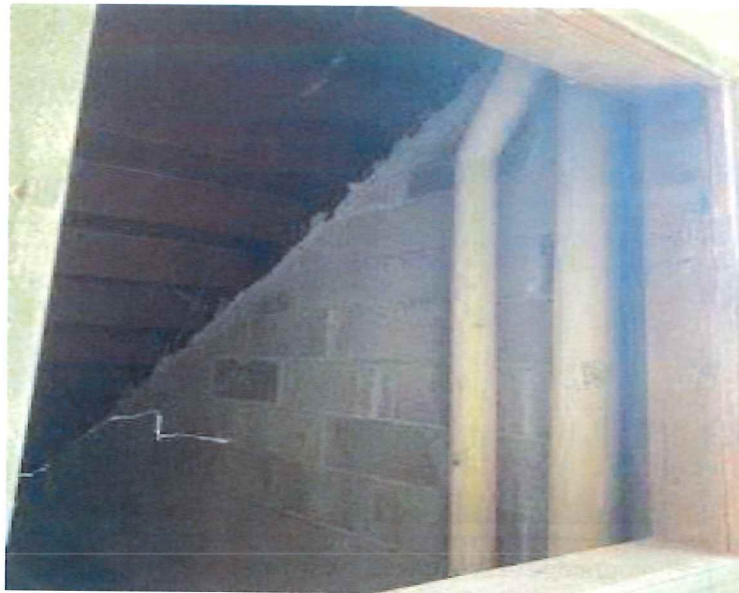
Photograph 4 – A view of the TSI on piping in the west space beneath stairs in the lower-level.

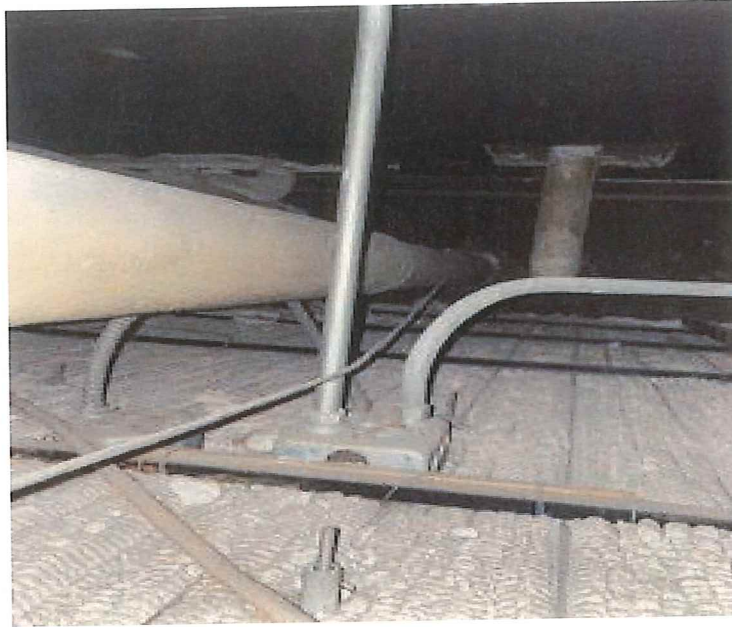
Photograph 5 – A view of the TSI on piping above ceiling outside the boiler room in the lower-level.

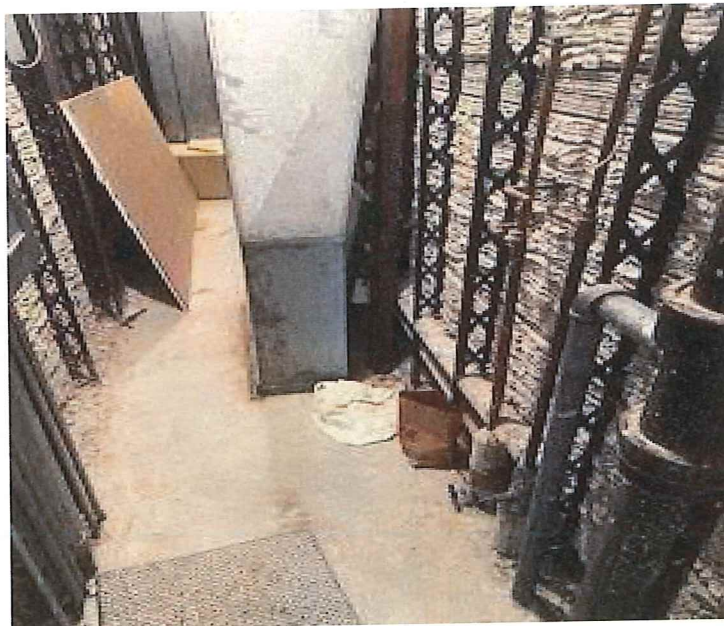
Photograph 6 – A view of the TSI on the 2<sup>nd</sup> floor in the bathroom chase.

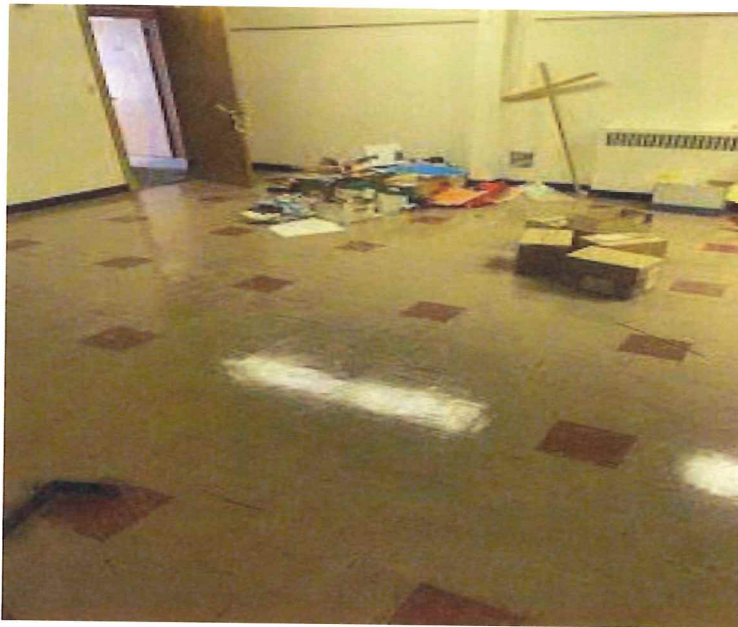
Photograph 7 – A view of the light brown 9'x9' tiles in the 2<sup>nd</sup> floor center room.

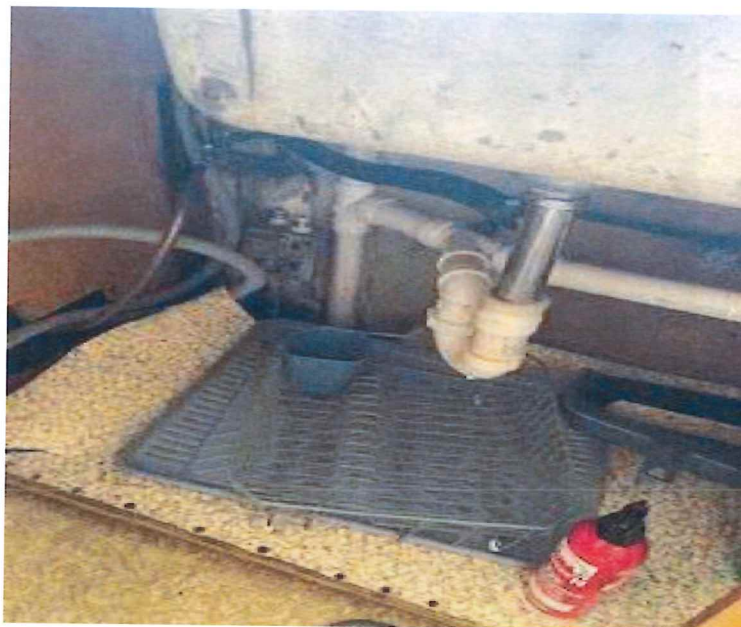
Photograph 8 – A view of the white linoleum beneath the kitchen sink on the 2<sup>nd</sup> floor.

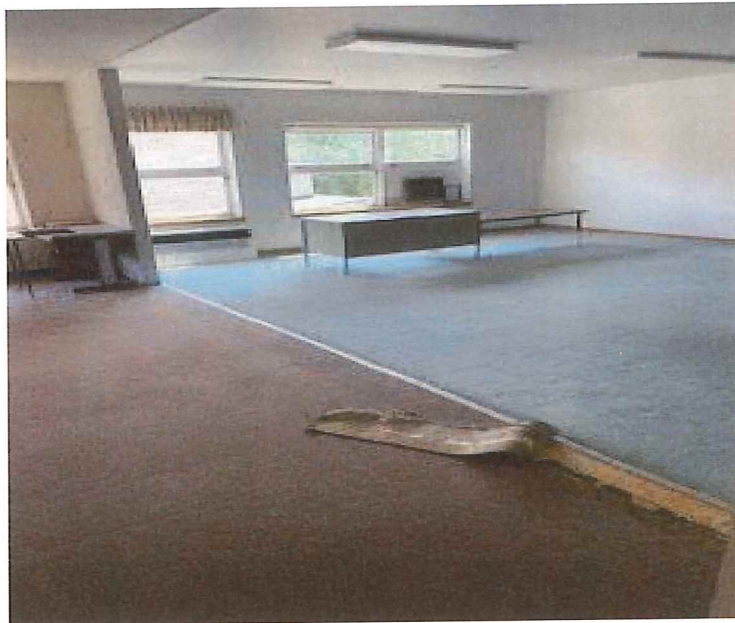
Photograph 9 – A view of the area with the black 9"x9" floor tiles in the 2<sup>nd</sup> floor south center room.

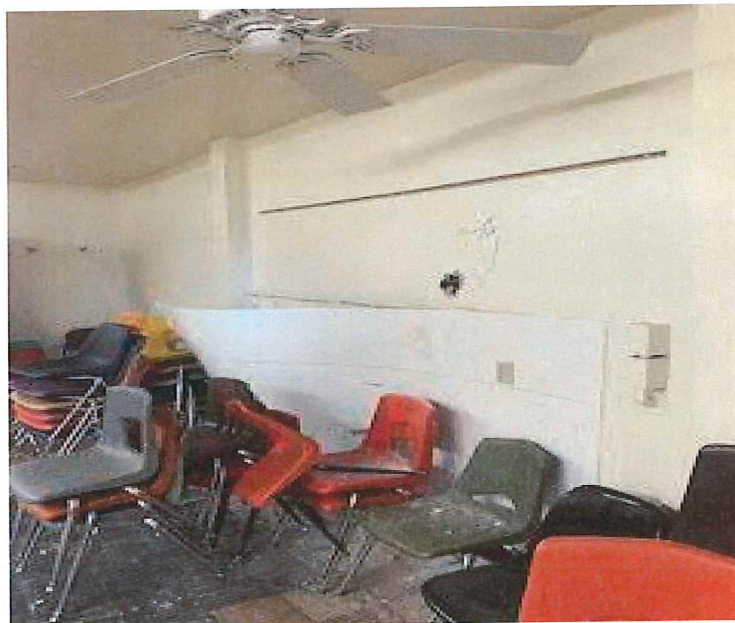
Photograph 10 – A view of the white plastic sheeting in the 2<sup>nd</sup> floor center room with TSI behind.

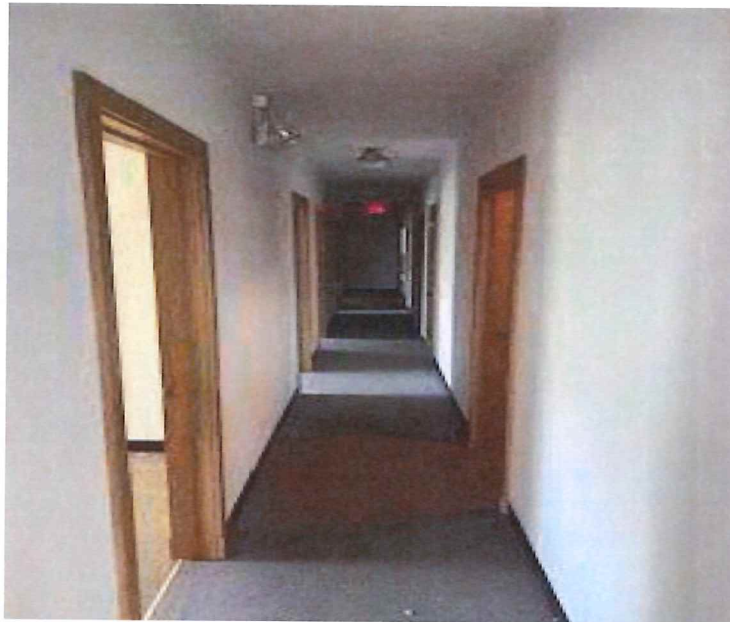
Photograph 11 – A view of a hallway on the 2<sup>nd</sup> floor with 9”9”s beneath.

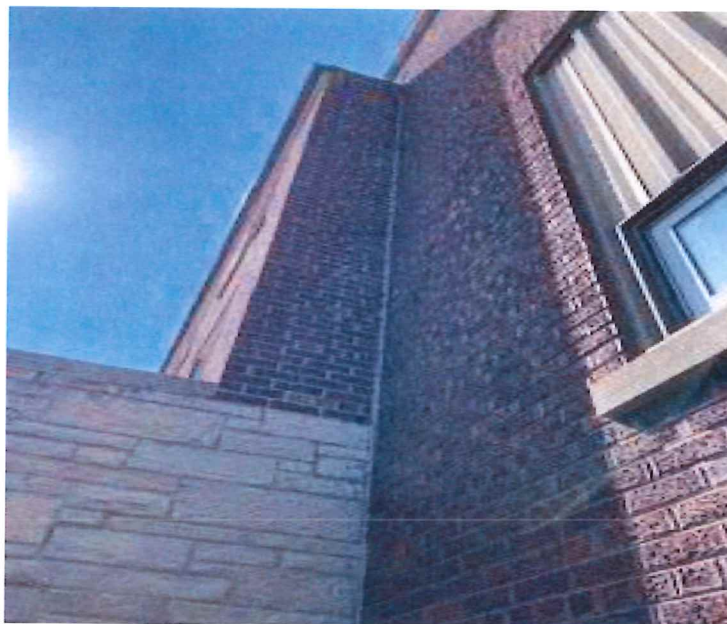
Building materials containing less than 1% asbestos, while not classified as an ACM by the United States Environmental Protection Agency (USEPA), do fall under the Occupational Safety and Health Administration (OSHA) Asbestos Construction Standard (29 CFR §1926.1101) and should be handled accordingly. During Keystone's assessment, the following building material was found to contain <1% asbestos.

Photograph 12 – A view of the <1% gray caulking/vertical seam on the S.E. portion of the building.

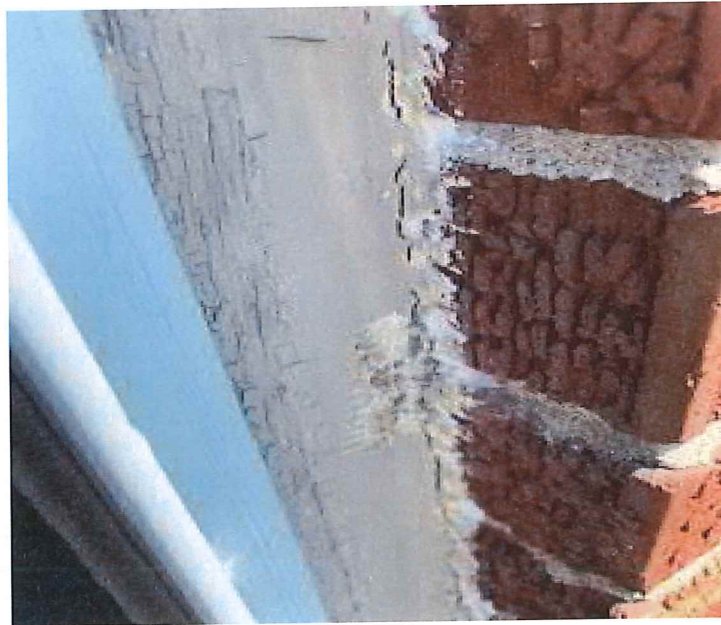
Photograph 14 – A view of the beige/gray window caulking.

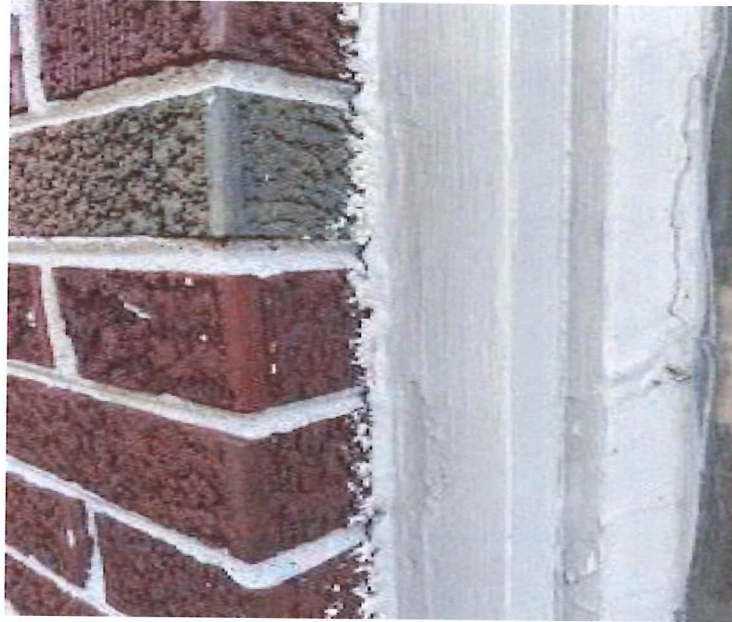
Photograph 15 – A view of the caulking and window glazing.

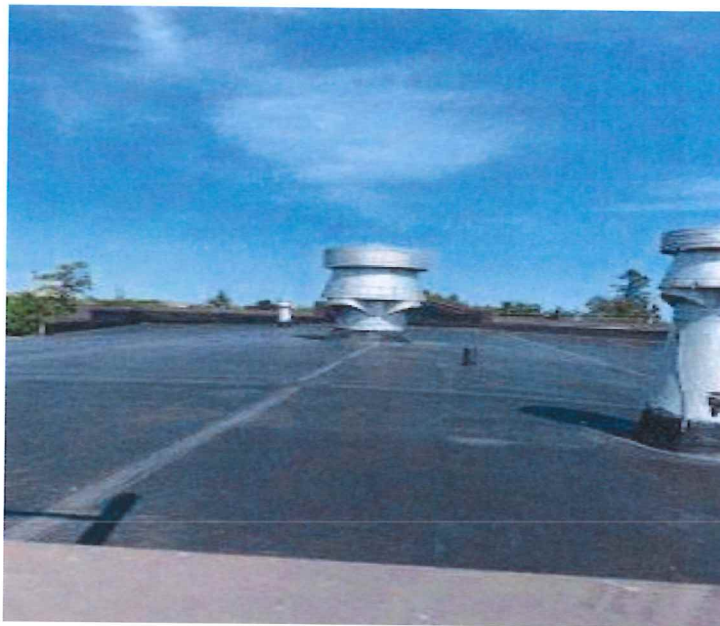
Photograph 16 – A view of the black roofing field with ACM mastic beneath.
