**To:** Mayor and Common Council  
**From:** Adam Tegen, Community Development Director  
**Subject:** **Blight Determination for Property Located at 828 Memorial Drive**

Blight Determination: 700 East Magnolia Avenue, Manitowoc, Wisconsin

Inspection Report

Lakeshore Mall

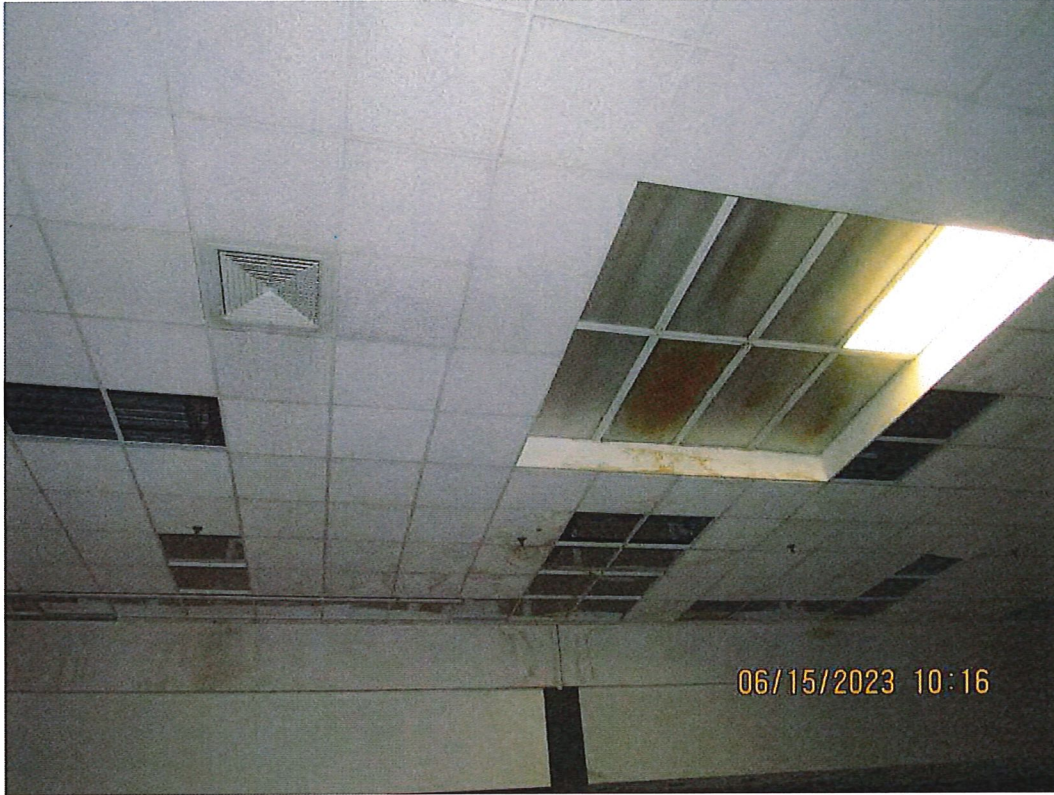
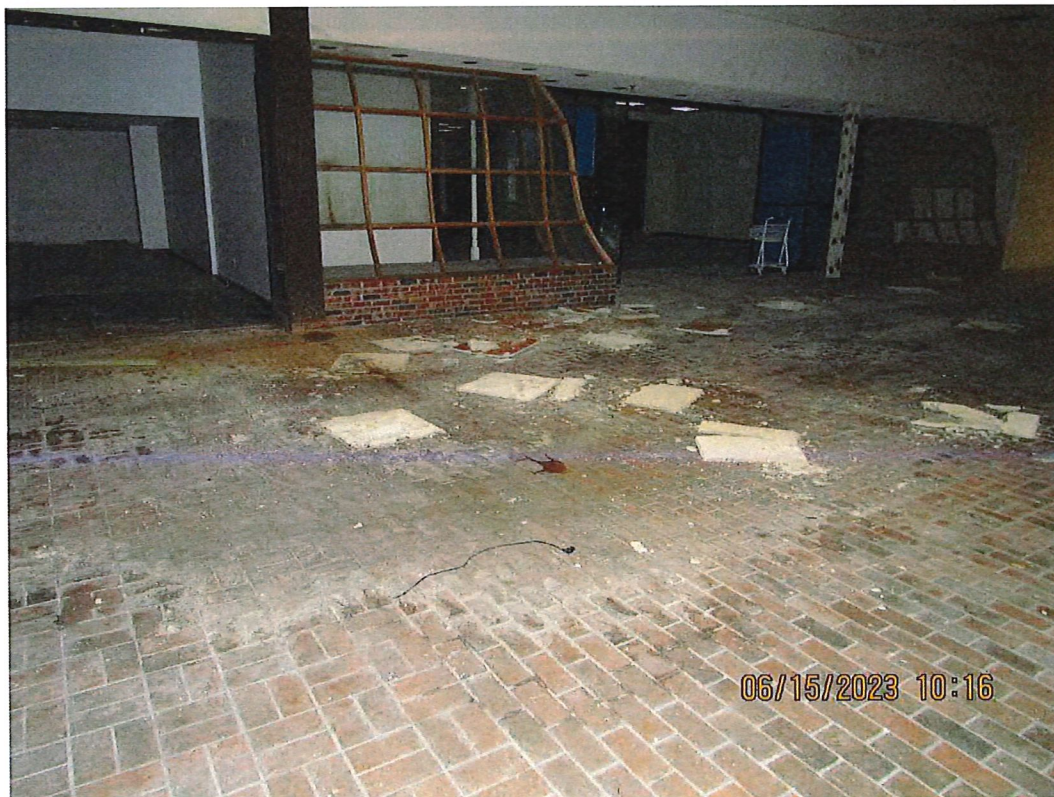
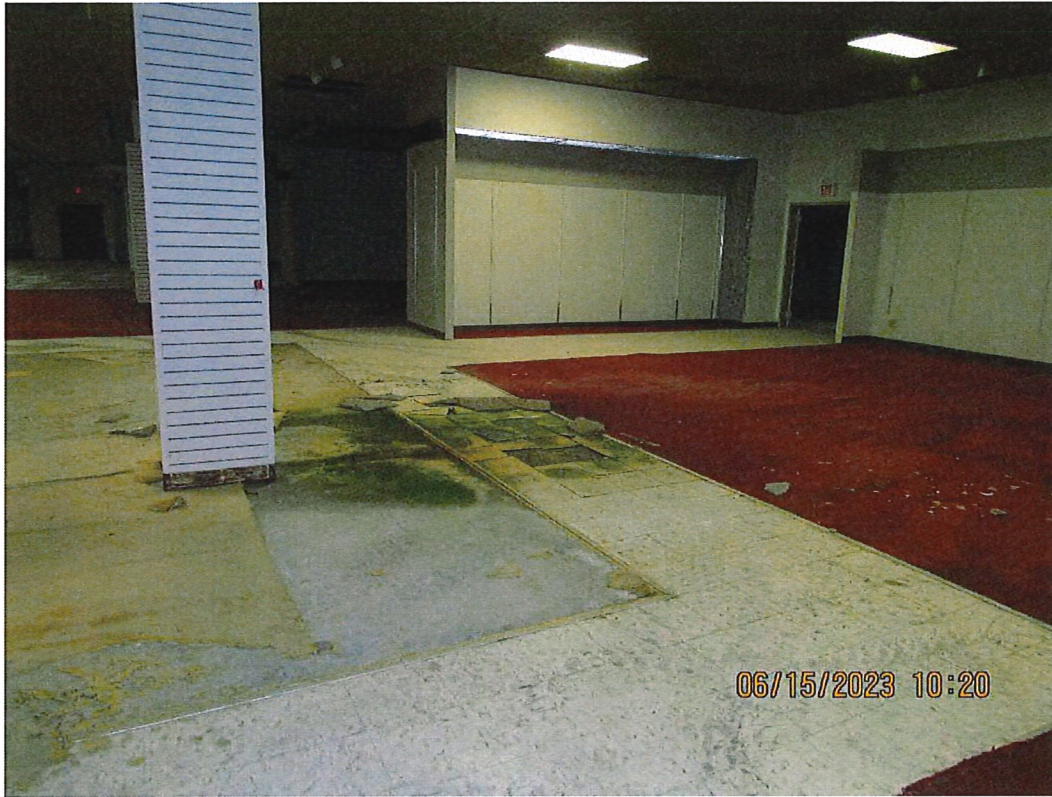
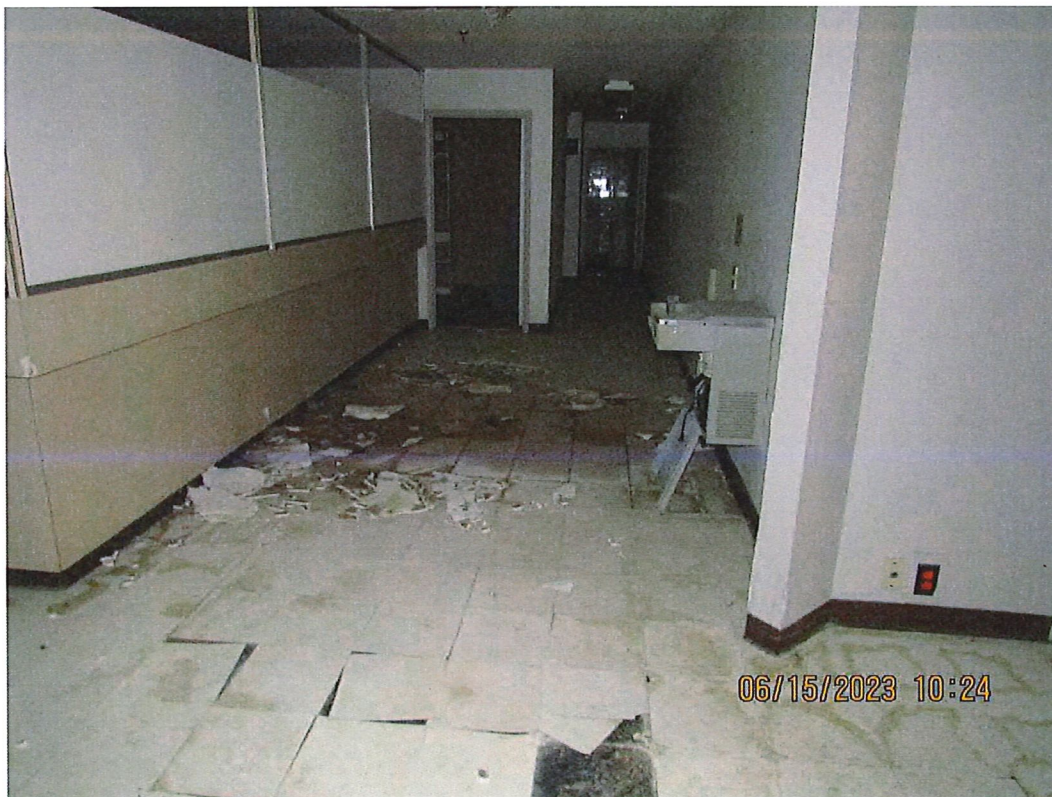
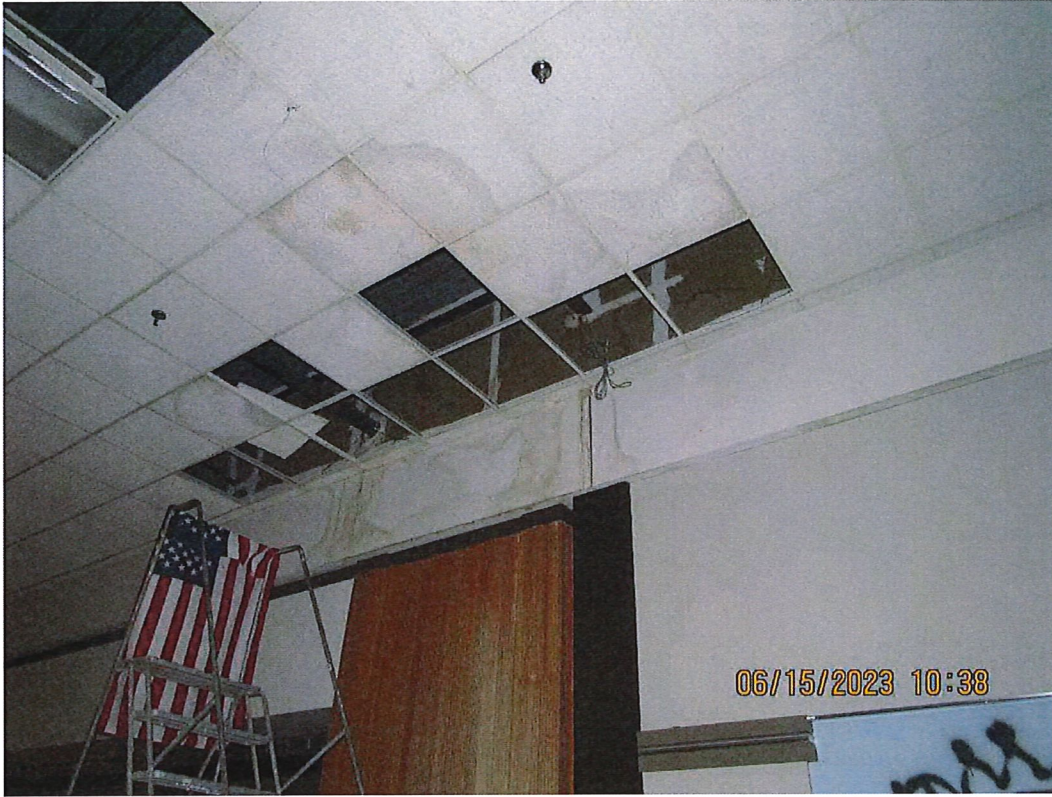
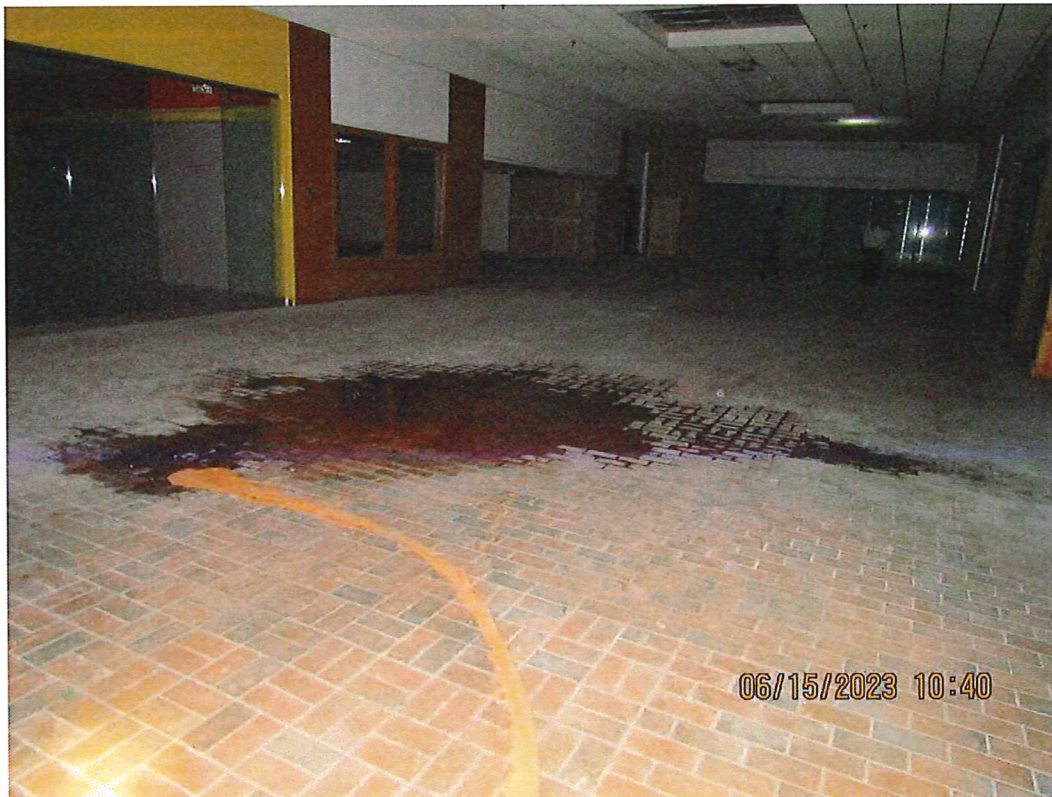
06/15/2023 at 1000hrs I, Housing Enforcement Inspector Keil served a special inspection warrant at 700 E Magnolia Ave. Also present during the inspection of the property were Inspector Nichols, Chief Blaser, Adam Tegen and Appraiser Art Sullivan. Photos were taken to document our observations.

1. Numerous missing/ broken ceiling tiles.
2. Numerous ceiling tile with staining/ mold growth and water damage. Some ceiling tiles are laying on the floor and are wet.

1. Missing ceiling tiles.
2. Numerous ceiling tiles are stained from water damage. Several tiles are laying on the floor and are wet.
3. A portion of the vinyl floor tile is loose and water damaged.

1. Missing ceiling tiles.
2. Numerous ceiling tiles are stained and water damaged.
3. Water is present on the floor from roof leaks.
4. Exposed electrical wiring.
5. Missing broken drywall. (2)

1. Exit lights not working.
2. Musty smell/ odor of mold was present.
3. Numerous missing ceiling tiles.
4. Mold growth on the rear storeroom wall studs/ drywall.
5. Mold growth on the office area floor tile, shelving and furniture.

6. Numerous ceiling tiles are stained from water damage and have mold growth present.
7. Side storeroom walls and shelving have a large amount of mold growth present.
8. Efflorescence/ mold growth on wall in front utility room.
9. Mold on carpeting.
10. Uncapped water/ drain lines.
11. Water present on the floor on the north end of the building from a roof leak.

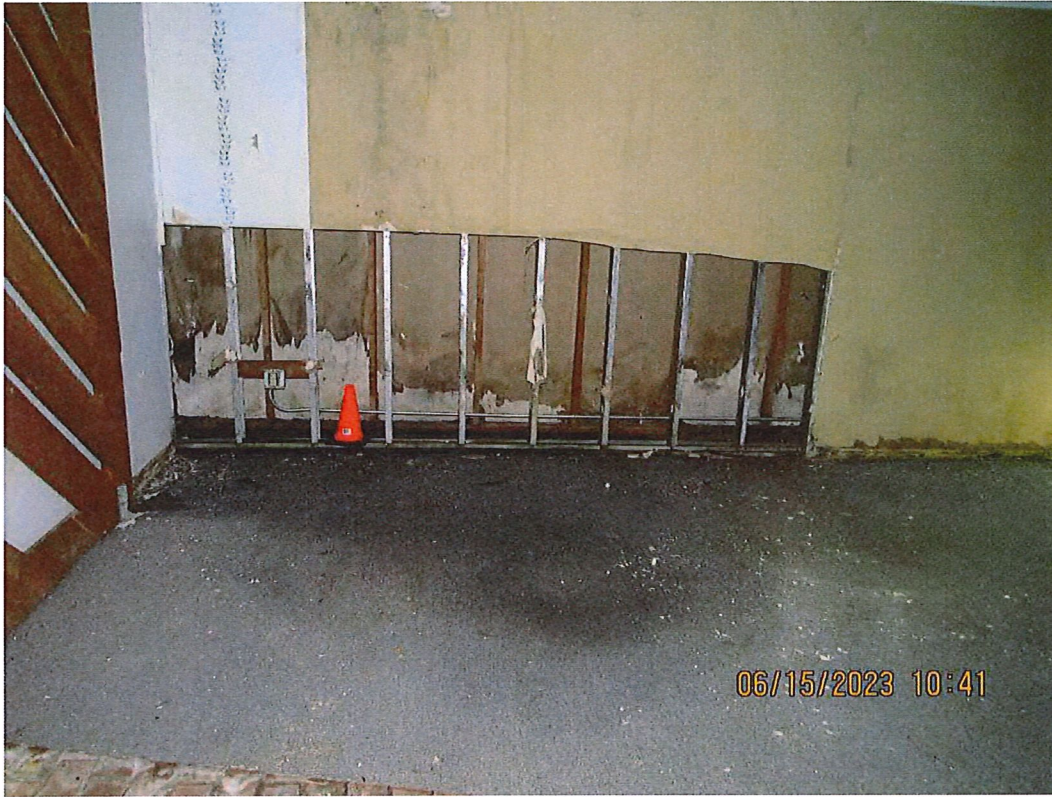
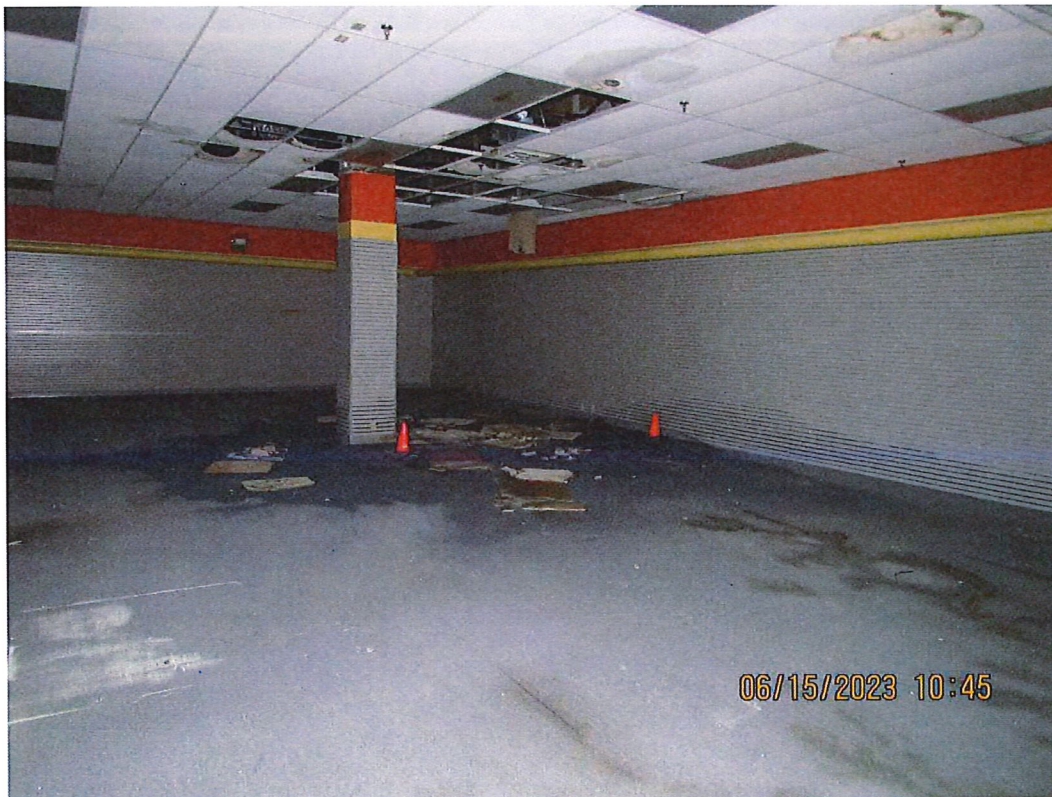
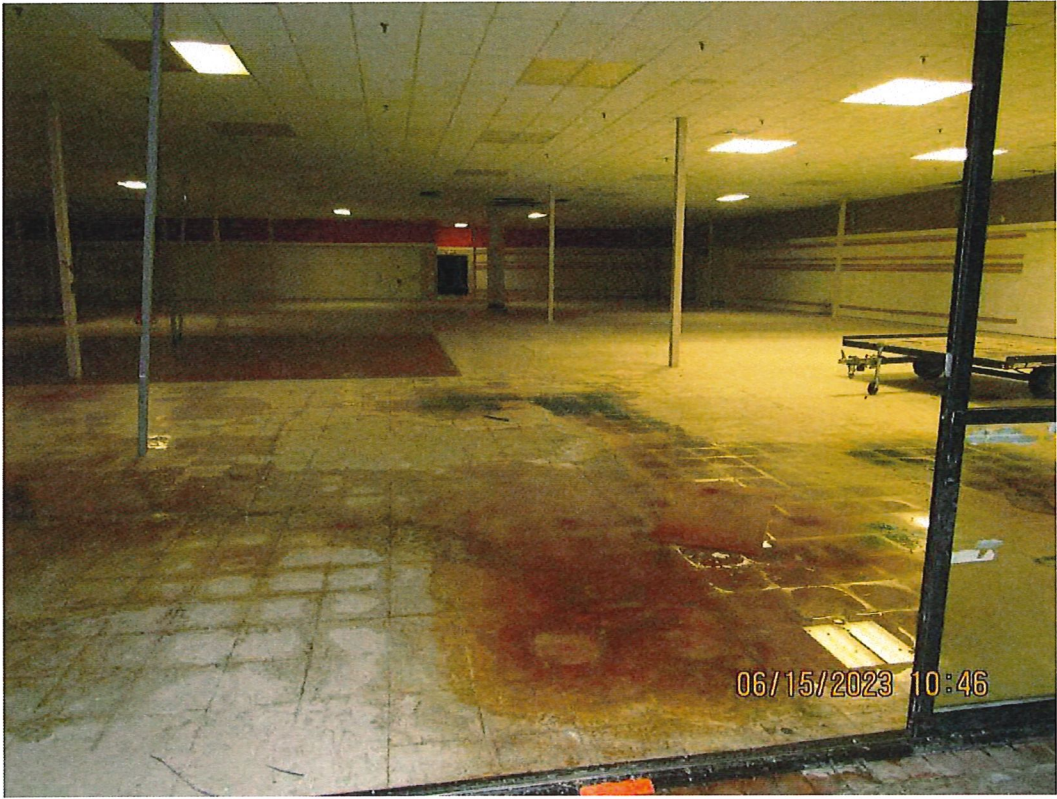
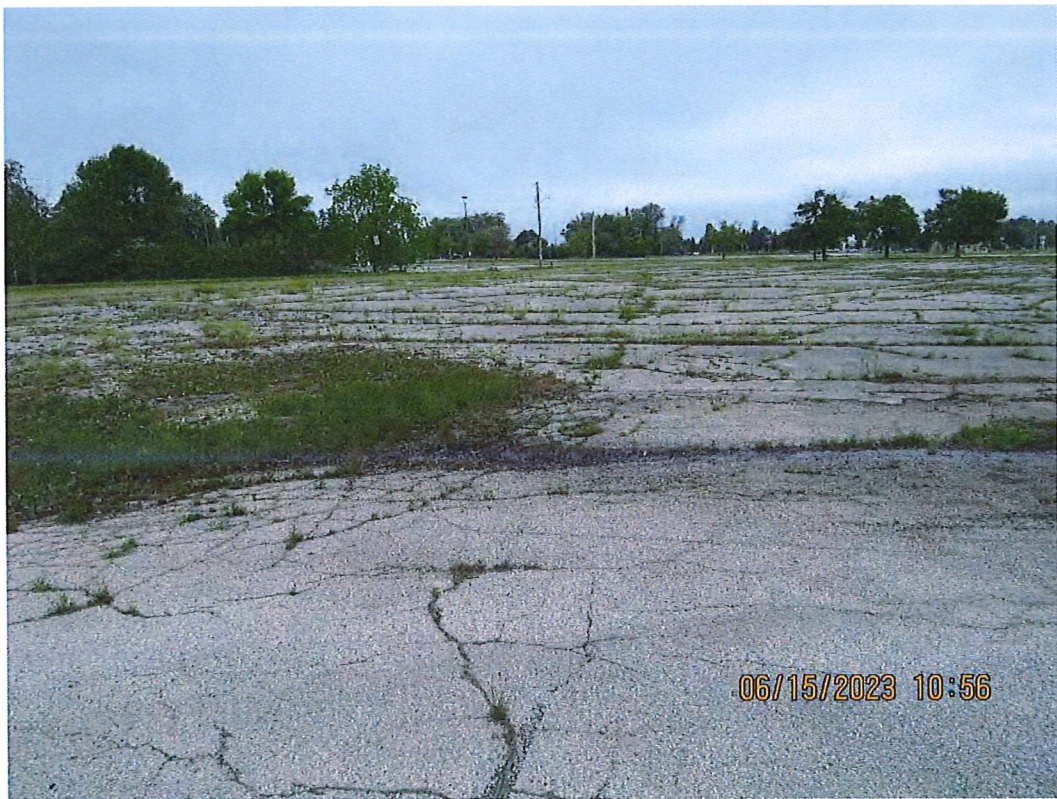
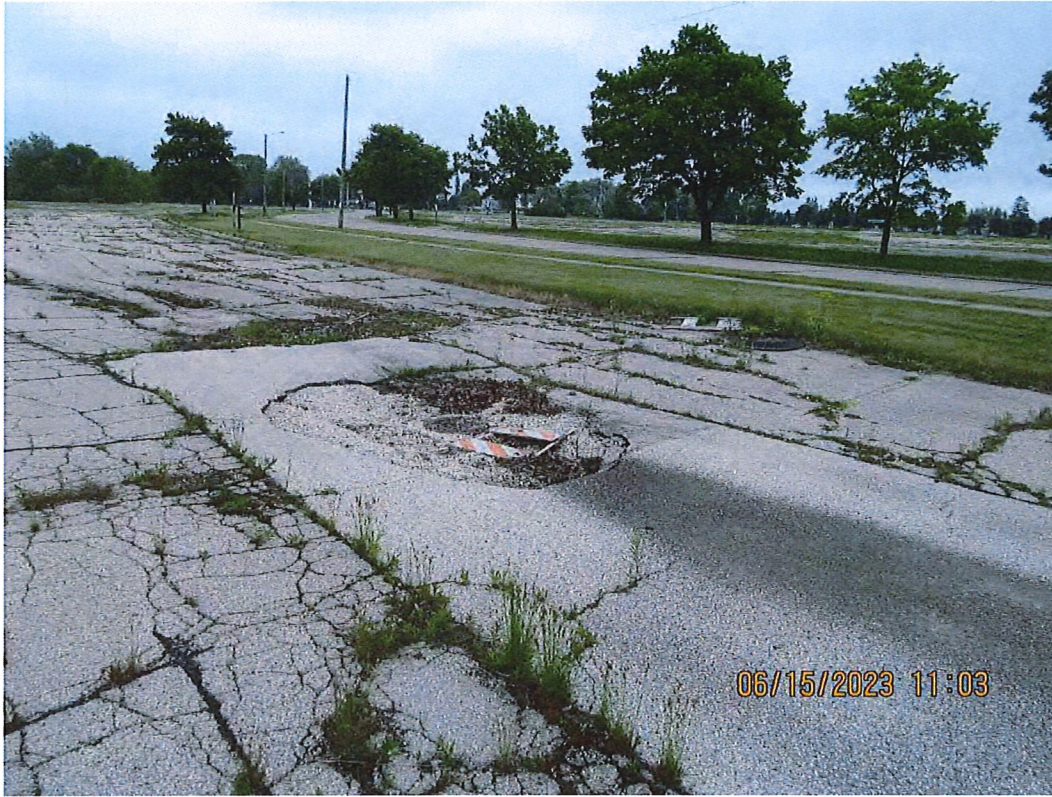
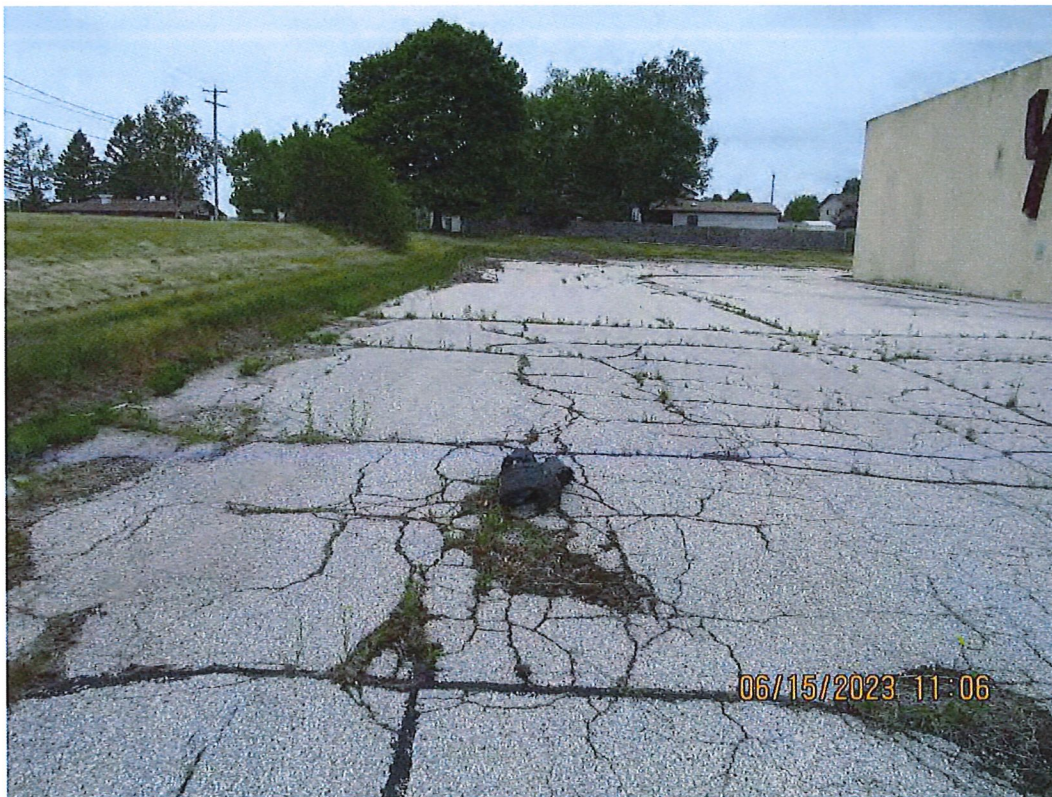
4. Broken toilet.
5. Uncapped water and drain lines.(2)
6. Mold growth on cabinetry.
7. Broken/ missing storefront window.
8. Mold growth on the wood wall coverings.
9. Water on floor from roof leak.
10. Water damaged/ stained ceiling tile.

1. Numerous missing/ water damaged ceiling tiles.
2. Water actively dripping onto the floor from the ceiling in a number of locations.

1. Water on floor in several locations from roof leaks.
2. Water stained/ damaged light fixtures.
3. Water damaged east wall.

It should be noted that nearly all of the fire extinguishers in the building had been discharged by acts of vandalism and had been removed from required locations.

1. Missing/ peeling paint. Rust staining on walls.
2. All windows and doors are boarded.
3. Parking lot is very deteriorated and in poor condition.
4. The fence at the rear of the property is deteriorating.
5. Parking lot lights are in poor condition.
6. Signage is present on the building for businesses that are no longer operating.
7. Brush, litter and debris is laying on the property.
