RE: 3711 Menasha Ave

Here is a photo of the outfall from 2013.

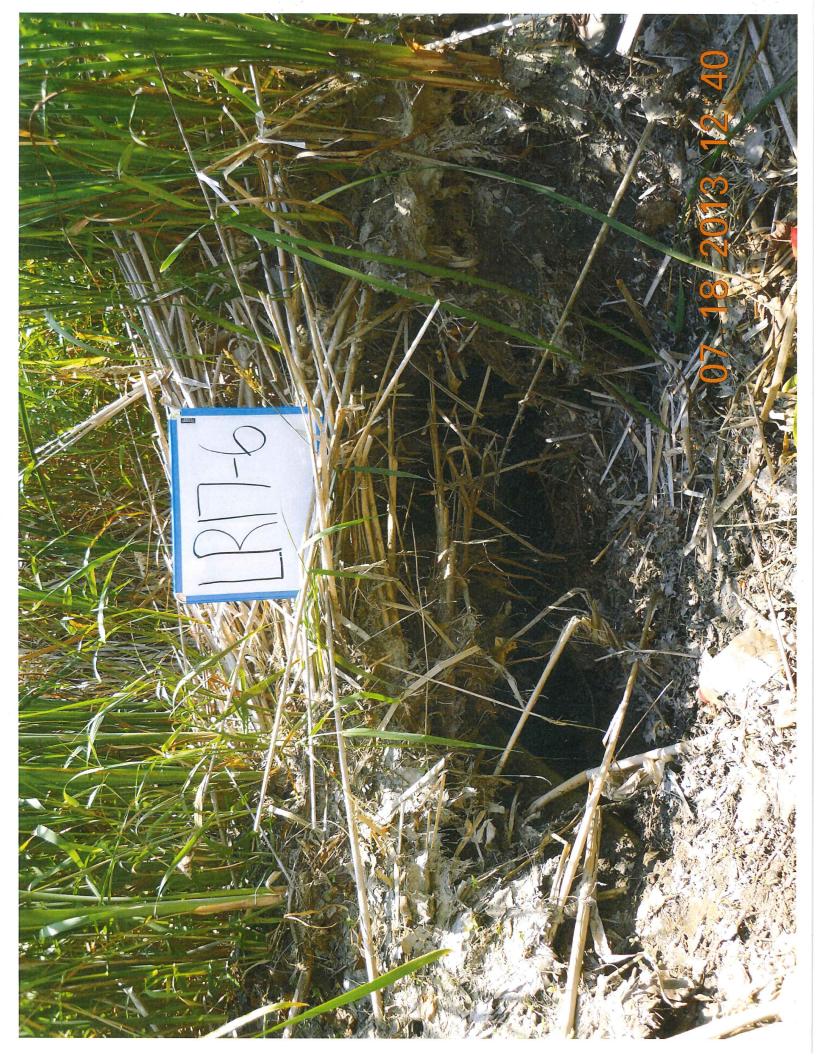
LR17-OUT6.jpg

That is a 30 inch storm sewer pipe that is  $\frac{1}{2}$  to  $\frac{2}{3}$ 's plugged with debris and this is due to the elevation of the wetland area being basically higher than the flowline elevation of the pipe.

The elevation of the outfall pipe is about 642.3 or lower. It is hard to tell from the topo. Maps but it looks like the wetland/floodplain area is at about a 644 elevation.

The discharge pipes on the north side of Menasha Ave. are completely overgrown. I took a photo, but the photo is actually about 10-15 east of the actual outfall. The whole area is overgrown and I could not see any outfall pipes, so I had no idea where they actually discharged.

I know that the pipe usually has sediment and water in it, but I think that we should at a minimum clear out all of the growth around the outfall and possibly do some minor ditching to get it to drain a little better. Thanks.
