Flooding Issues on Pine St. - N. 5th to Lincoln Blvd.

Subject: Flooding Issues on Pine St. - N. 5th to Lincoln Blvd.

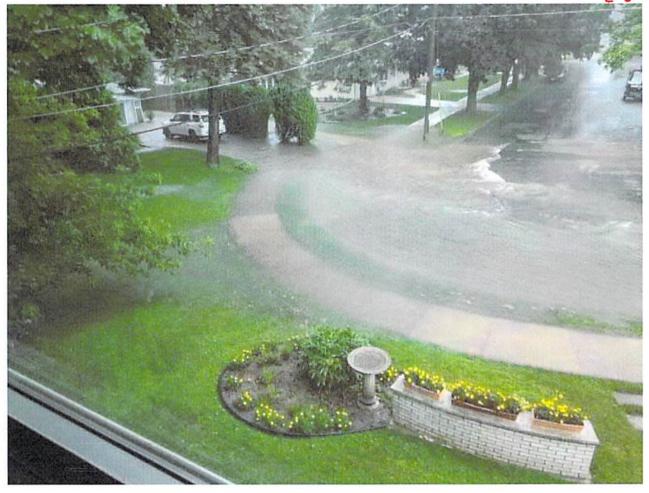
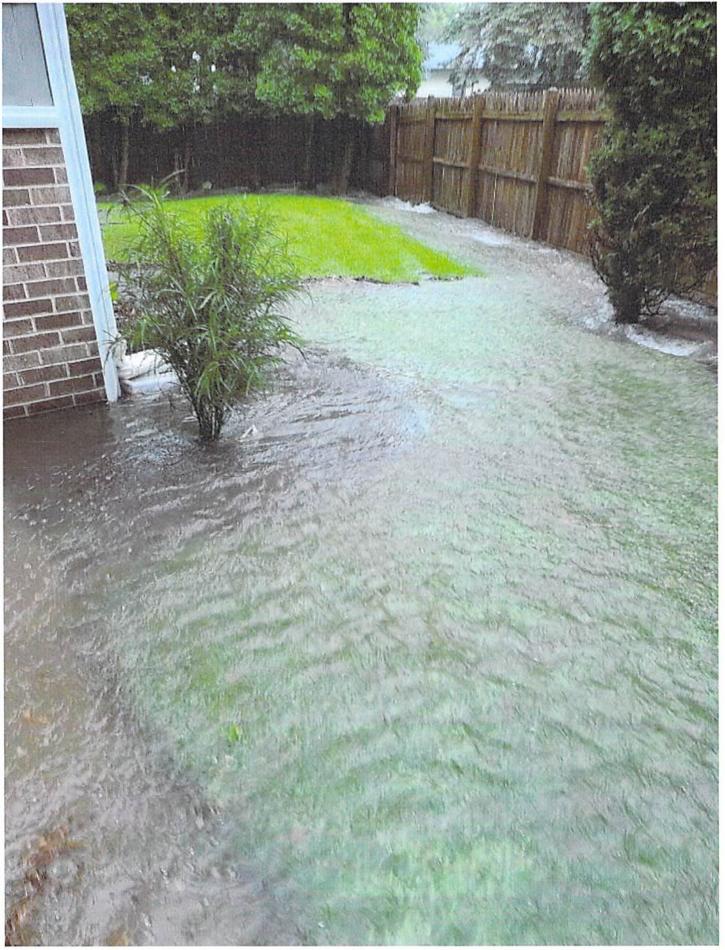
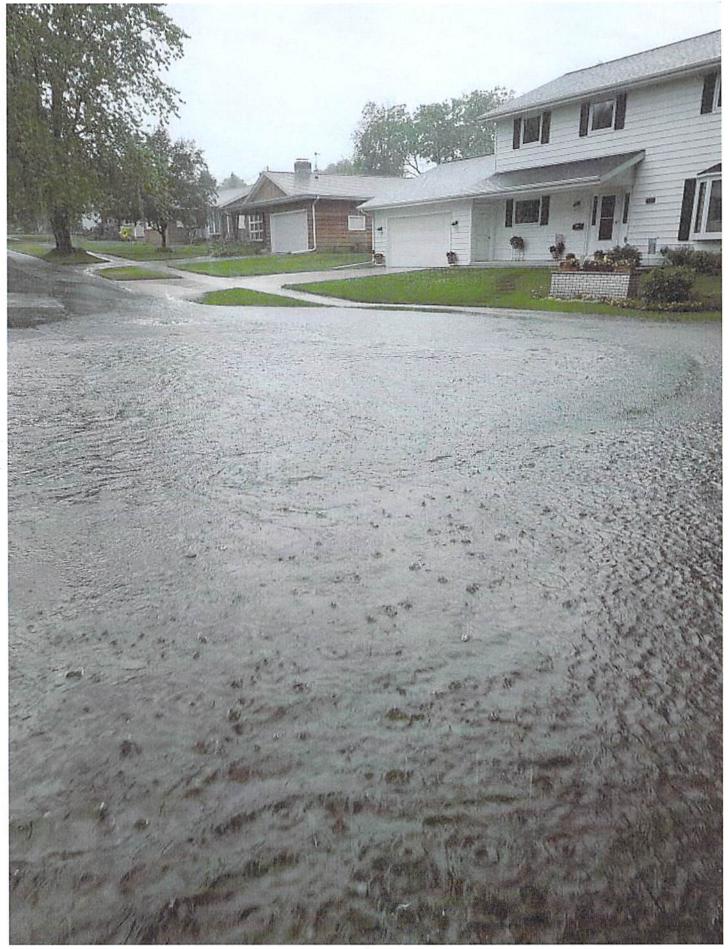
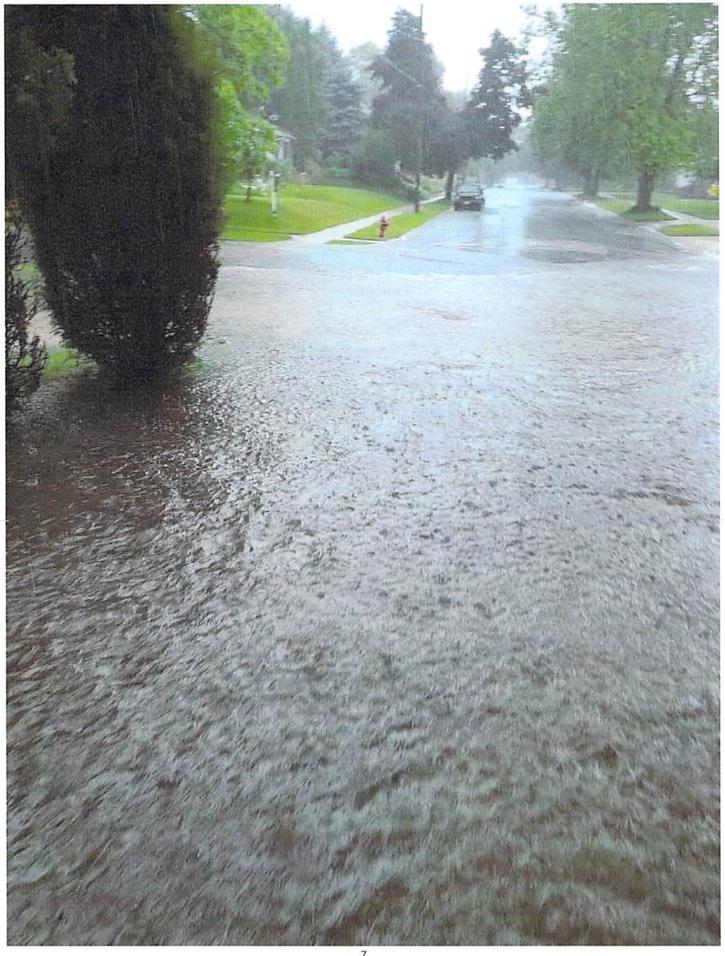
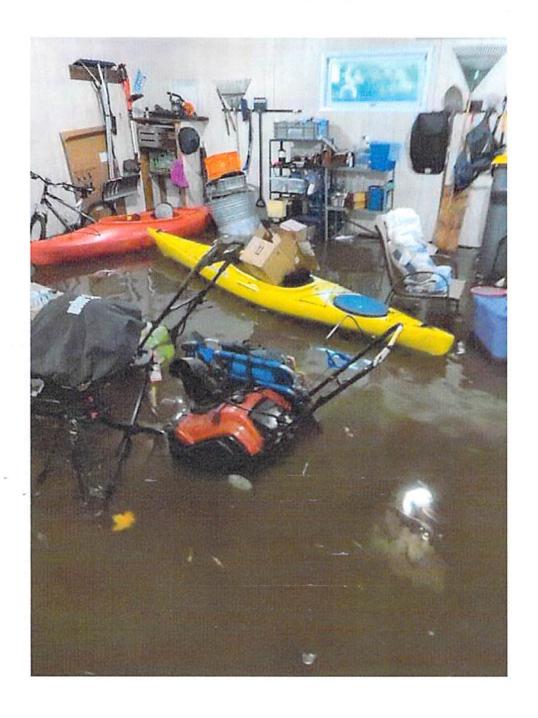
It was not this bad when I got there (I believe Mike saw the water against the garage as he was there for a while before I got there), but one of the neighbors or property owners had already pulled off every inlet cover so the water could get in them.

I asked Sonja to put this item on the August PI Comm. Agenda.

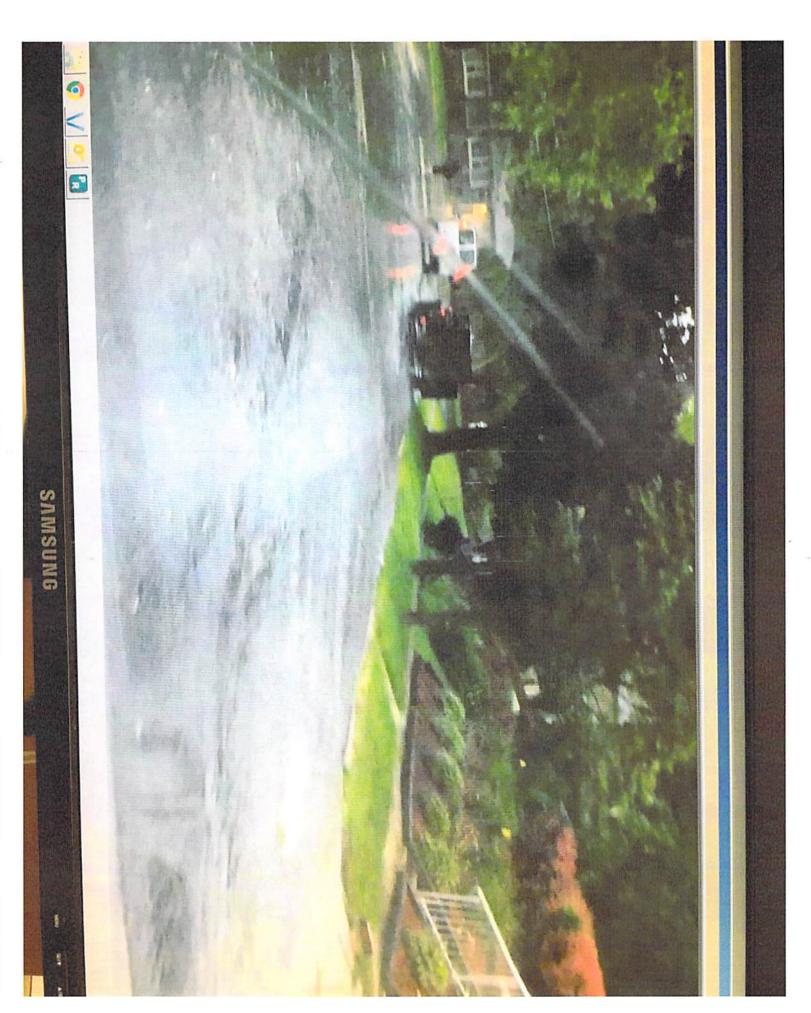
Attachments: IMG_2046.JPG

We also had flooding issues in the cul-de-sac at N. 5th and Pine St.

One of the property owners was out there and had lifted up all of the inlet grates so that the stormwater could get in. The grates were plugged with debris.

The existing storm sewer that runs down the ped-way between Pine and Shorewood Blvd. is a 27 inch pipe and it was full.

The stormwater was sheet draining down the south gutter line of Pine St. from Lincoln Blvd. to N. 5th St. The water extended out almost all the way to centerline.

Part of the problem is that this old neighborhood has mostly 2x2 inlets and those plug up very quickly.

There are also long blocks with no inlets, especially along Lincoln Blvd.

Mike Zimmer and his seasonal employees were there and helped put the grates back on the inlets.
